Naval Research Laboratory

NRL Memorandum Report 6404

## Electronic Space Fire Protection: Halon 1301 Cabinet Penetration Tests

January 26, 1989

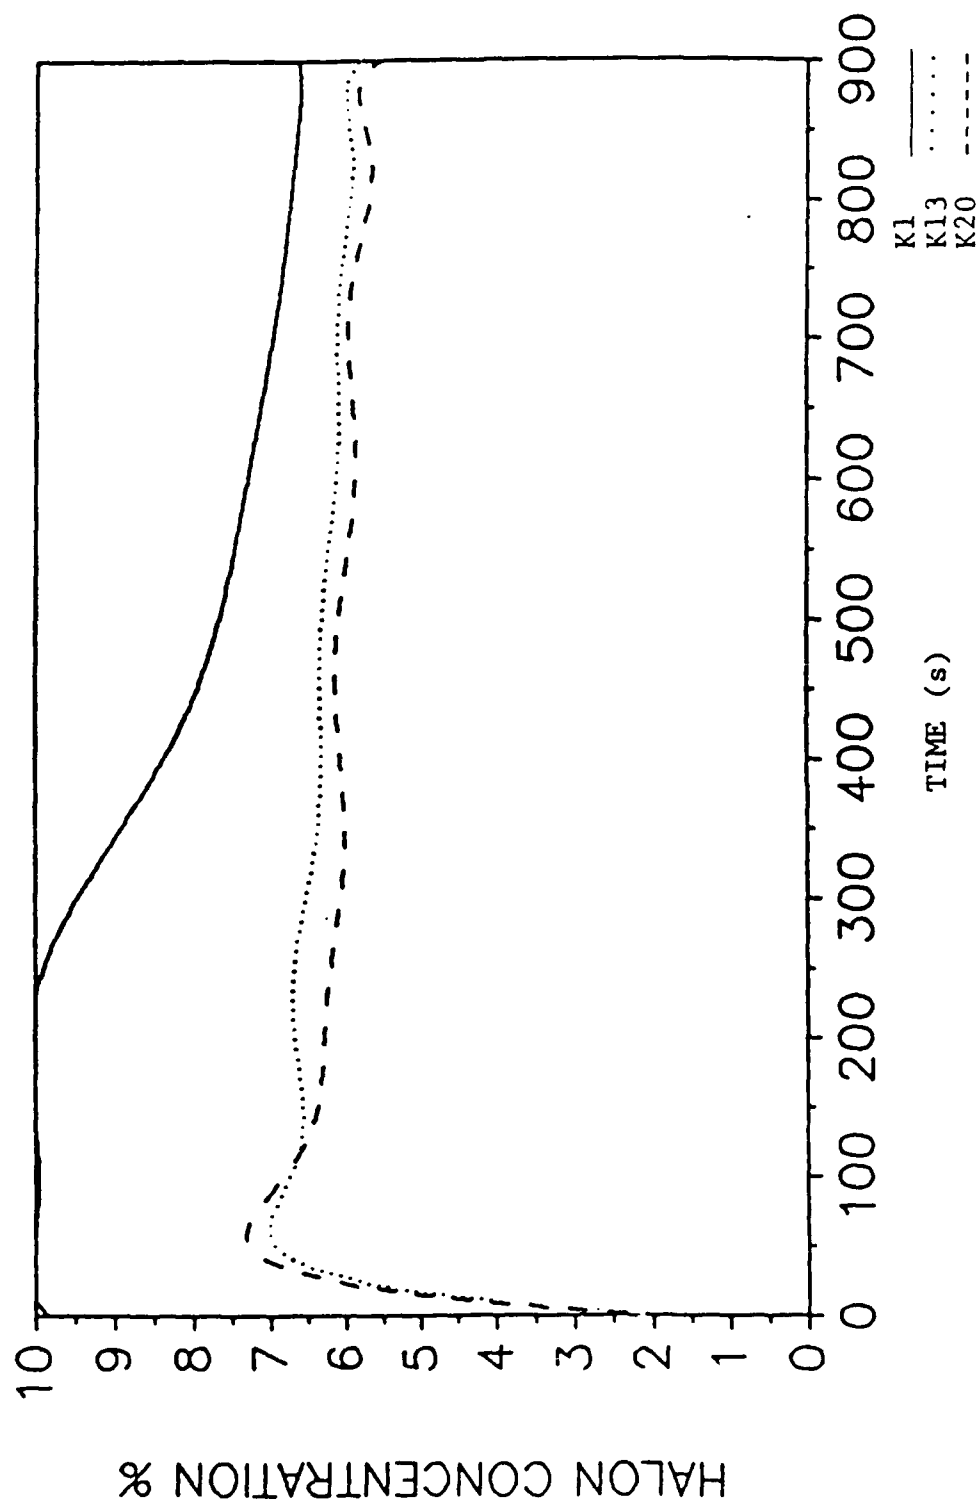
Fig. 16 - Test 2, Halon concentrations beneath raised deck, fans on

Figures 15 and 16 show data from sampling points K1, K13, and K20. These sampling points were all located beneath the raised deck area, as shown in Figs. 4, 5 and 6. Sampling point K1 is located inside a large cable bundle, while K13 and K20 are positioned in open air 15.2 cm (6 in.) above the actual floor. Review of Figs. 15 and 16 reveal immediate Halon 1301 penetration into the instrumented cable bundle. All under floor concentrations were well in excess of the 6% design concentration. The reduction shown in Fig. 15 of probe K20 occurred when sampling point K1 and K0 were interchanged. This was done by the operators of the Halon analyzers to confirm the low local concentration recorded at point K0. As discussed previously, this was caused by the inadvertent operation of a recirculation duct.

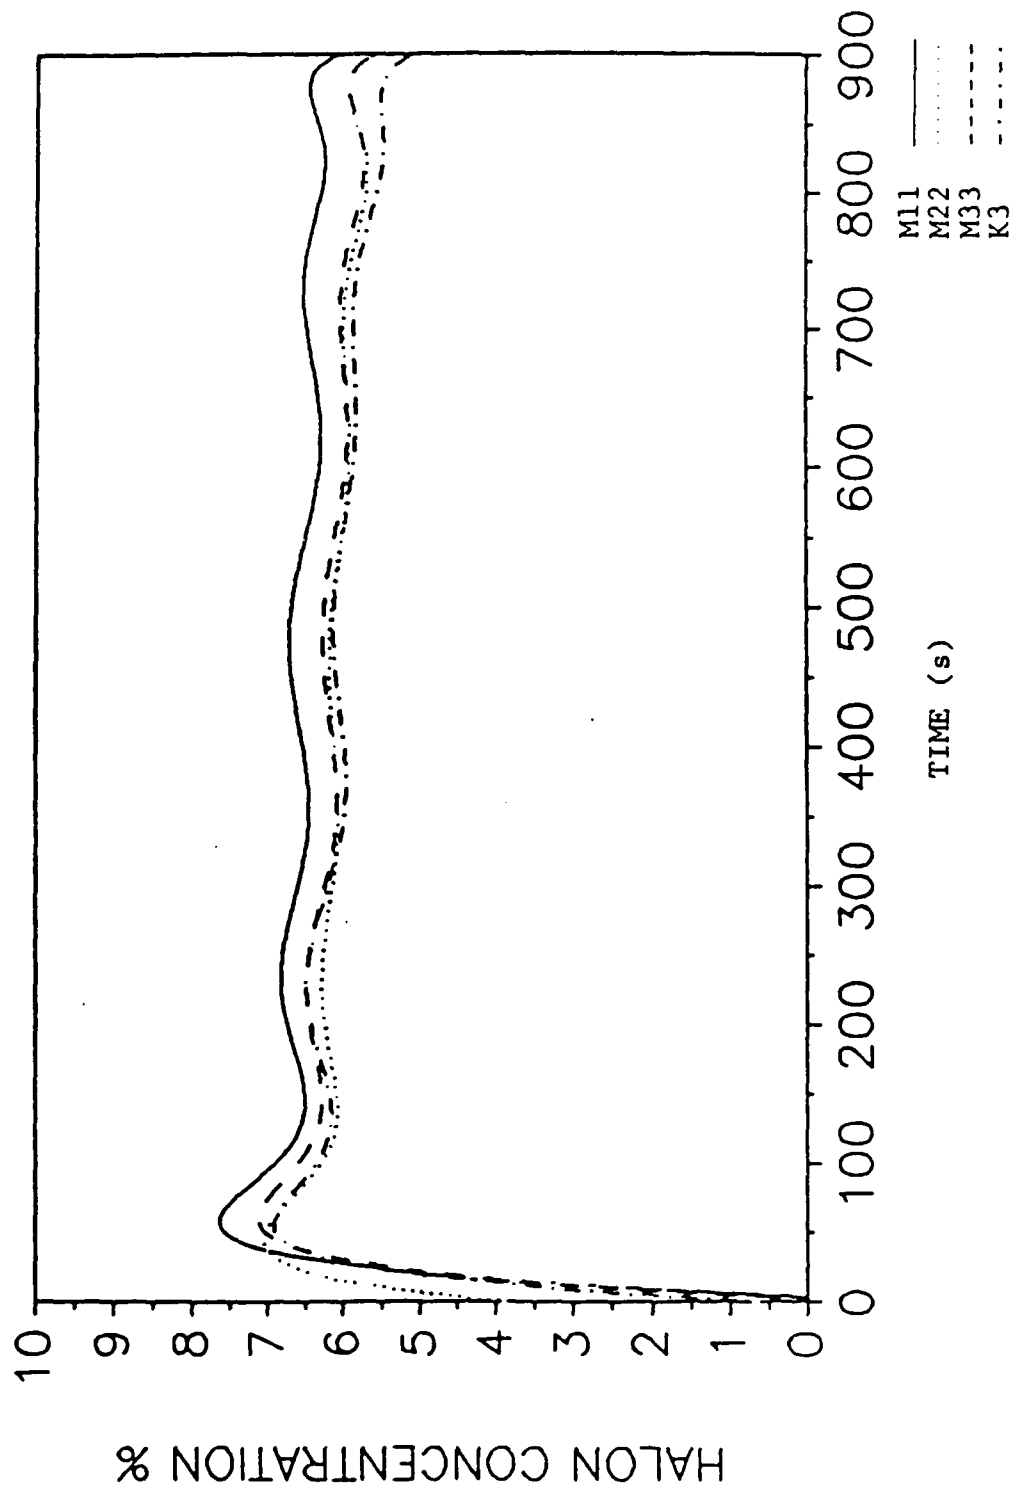
Fig. 17 - Test 1, Halon concentrations 1.2 m (4 ft) above actual floor, fans off

The Halon 1301 concentrations produced by this total flooding system appear to be uniform. This is evidenced by the concentration profiles shown in Figs. 17 and 18. These figures, again, represent data recorded from Test #1 and #2, respectively. Figures 17 and 18 were constructed by superimposing selected data obtained from sampling positions A, B, C, and D. The specific positions were all at the same approximate vertical elevation 1.2 m (4 ft) above the actual floor. Each figure shows recorded data obtained from sampling points M11, M22, M33, and K3. The intent was to show any concentration variations produced 1.2 m (4 ft) above the actual floor at remote locations. The excellent agreement of the data shown in Figs. 17 and 18 also lends credibility to all the results present herein. That is, it appears there were no localized pockets of Halon 1301.

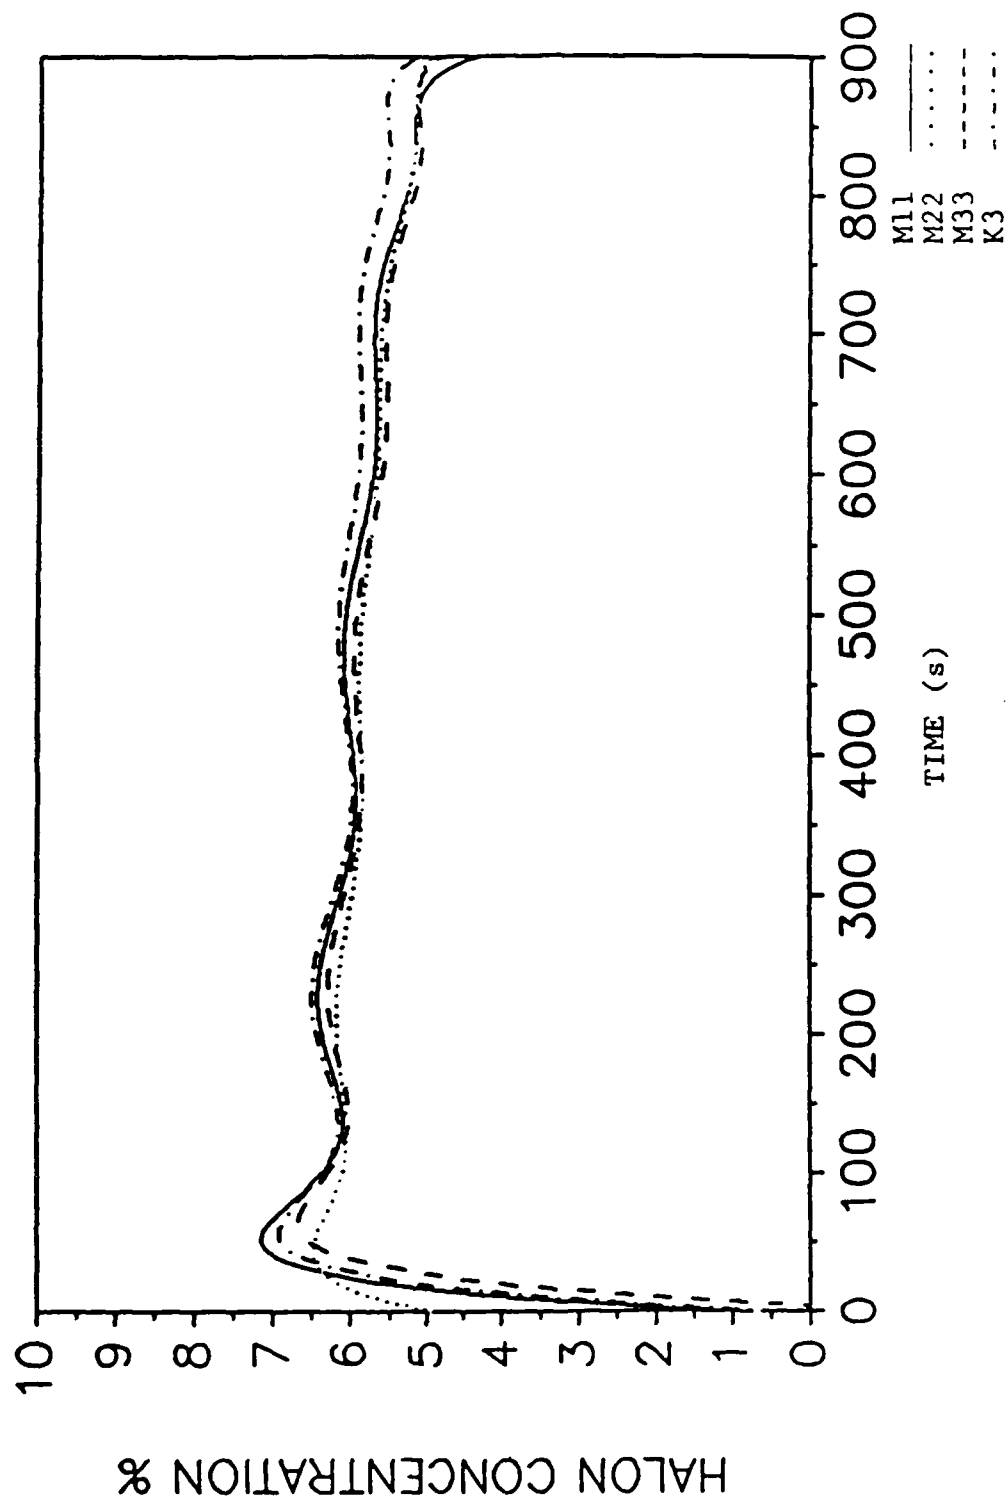
Fig. 18 - Test 2, Halon concentrations 1.2 m (4 ft) above actual floor, fans on
